Nurse AdviseERR®

Smart infusion pump investigations after an unexplained over-infusion

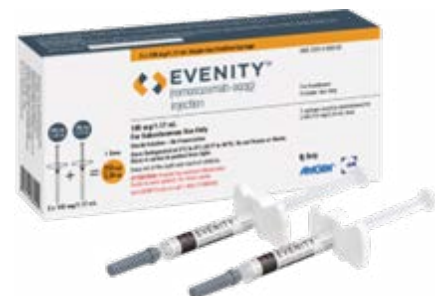
Figure 1. A dose of Evenity requires the administration of two subcutaneous injections. The manufacturer, Amgen, packages two prefilled syringes in one carton. The syringe needles do not have safety guards, so the potential for needlestick injuries is high.

In one case, a nurse in an outpatient infusion setting experienced an accidental needlestick injury while administering Evenity to a patient. The needles on Evenity syringes lack a safety device; they are not retractable or even removable, so the nurse was unable to change the needle to one that has a safety guard. Other organizations have reported the same concern about accidental needlesticks with this product, which we wrote about in our September 2022, issue (www.ismp.org/node/38617). All the reports noted the lack of a safety guard and suggest adding one.

Much of this safety issue could be avoided if all prefilled syringes had engineering controls that protected people, not just healthcare professionals, against needlestick injuries. ISMP asked the US Food and Drug Administration (FDA) and manufacturers to address this concern with a requirement for ALL prefilled syringes to have a safety guard. We also spoke with Amgen directly about the need for a needle safety guard for Evenity and hope they will consider adding one. Alternatively, companies can make prefilled syringes without an affixed needle so that a safety needle can be placed on the syringe before use. This would allow conformance with the OSHA requirement and help protect people against injury from an uncovered needle after administration.
