Nurse AdviseERR®

Saline infusions and flush syringes may not be as “harmless” as you think – scanning will help

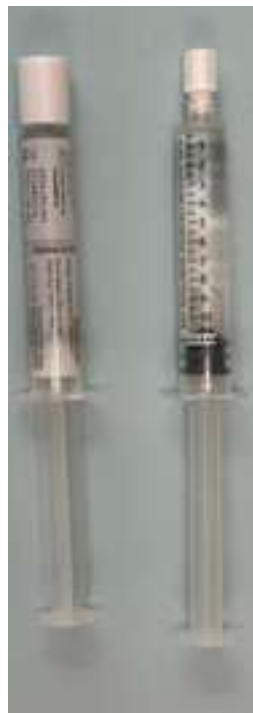
In a report we received, a nurse removed what she thought was a 10 mL 0.9% sodium chloride flush from a tray in the patient’s room, then almost gave it during a bedside procedure. Before administration, the nurse read the label and identified that the syringe contained phenylephrine 1,000 mcg/10 mL instead of saline. The prescriber ordered the phenylephrine to be stored at the bedside in case the patient experienced hypotension during the procedure. The hospital had purchased the phenylephrine syringe from STAQ Pharma, a 503B outsourcing facility. The hospital reported that the phenylephrine syringe which previously had a red cap, now has a white cap, similar to the sodium chloride flush syringes (BD) (**Figure 1**). STAQ Pharma told the hospital that they changed the phenylephrine cap color from

Figure 1. Instead of a 0.9% sodium chloride flush (right, BD), a nurse nearly administered phenylephrine 1,000 mcg/10 mL (left, STAQ Pharma), packaged in a similar-looking syringe that was kept at the bedside prior to a procedure.

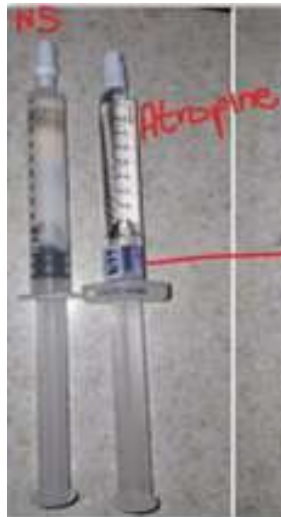
In another case, a hospital recently procured atropine sulfate injection 1 mg/10 mL syringes manufactured by Amneal. A nurse contacted the pharmacy to report that the atropine syringes were nearly indistinguishable from the 0.9% sodium chloride flush syringes made by BD (**Figure 2**). The nurse noted that these atropine syringes do not come with an overwrap like their previously purchased atropine product, and the labels and printing on the syringe were incredibly small, making it difficult to identify the contents.

Figure 2. The 0.9% sodium chloride flush syringe by BD (left) looks similar to the atropine syringe by Amneal (right).

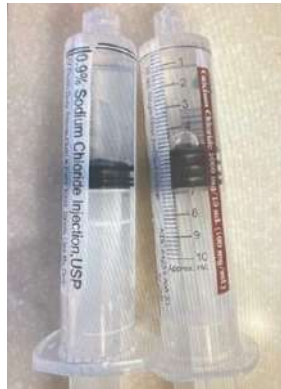
In yet another case, a hospital reported that once a practitioner removes the overwrap, sodium chloride 0.9% flush syringes (Excelsior Medical) look very similar to calcium chloride 1,000 mg/10 mL syringes (Medefil) (**Figure 3**). This led to a close call in an operating room where barcode scanning has not been implemented.

Figure 3. The 0.9% sodium chloride flush syringe by Excelsior Medical (left) looks like the calcium chloride syringe by Medefil (right), once removed from their overwraps.

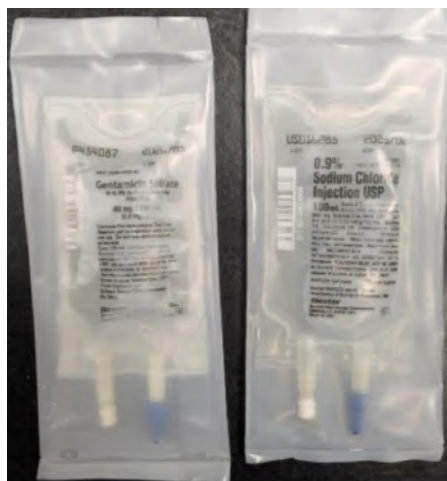
Errors and close calls can also occur with premixed saline infusions. In a recent case, a radiology technologist removed a 100 mL bag of what he thought was 0.9% sodium chloride from a bin in the imaging center. When loading the fluid into the computed tomography (CT) contrast power injector, the technologist noticed the label looked different than the one on the bag he typically used. He did not administer the fluid and immediately brought the bag to the pharmacy. The pharmacist identified that it was gentamicin 80 mg/100 mL in 0.9% sodium chloride injection. The pharmacist called the imaging center and asked the nurse to check the bin where the 100 mL saline bags were stored. She found additional bags of gentamicin, which were sequestered. Baxter makes both products, and they come in similar packaging (**Figure 4**).

Figure 4. Bags of gentamicin 80 mg/100 mL injection (left) were found mixed in the bin used to store bags of 0.9% sodium chloride 100 mL injection (right).

radiology technologist did not read the label or scan the barcode before restocking the bags, then unknowingly added the gentamicin bags to the 0.9% sodium chloride bin.

Of the 25 gentamicin bags purchased, 17 were located, and it was presumed that 8 patients might have received 30 to 50 mL (24 to 40 mg) of gentamicin in error. The radiology director contacted the physicians of the patients who may have been impacted. A pharmacist reviewed the EHR for all of the potentially impacted patients to assess allergies/reactions, weight (to determine mg/kg gentamicin dose potentially administered), laboratory monitoring (e.g., renal function), and if any readmissions could be correlated. They did not identify any actual patient harm.

Restrict medication purchasing. Review medication and fluid (including saline fluids and flush syringes) ordering policies and procedures for all organizational locations (e.g., radiology, perioperative areas, outpatient infusion centers), including those purchased by non-pharmacy departments. Ensure medications are restricted to pharmacy purchasing unless an exception is specifically justified.

Maximize barcode scanning. Use barcode scanning when receiving, dispensing, filling the ADC or other storage location, and prior to administering any medication, including sodium chloride infusions and flush syringes. The ISMP [Targeted Medication Safety Best Practices for Hospitals](#), Best Practice 18, calls for maximizing the use of BCMA by expanding use beyond inpatient care areas, including perioperative areas, radiology, and the emergency department. Regularly observe scanning practices and review scanning data (e.g., compliance, alerts) to identify products commonly administered without scanning to help uncover potential workflow or product issues. Supervisors should be on constant lookout for staff who bypass this important safety system; gather feedback from end users about barriers to scanning (e.g., access to equipment) and solutions to address them.

Safeguard storage. Store look-alike products separately and in a way that keeps their labels as visible as possible. Manufacturers' and outsourcers' product labels and packaging might change, so identifying physical features (e.g., cap color, label color) alone should not be used to identify any medication. This speaks to the importance of scanning the barcode along with reading the product label.

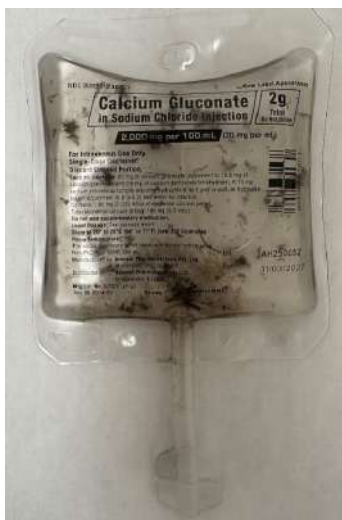
A hospital reported sterility concerns with a calcium gluconate 2,000 mg/100 mL injection bag manufactured by Amneal (NDC 80830-2363-1, lot number AH250052, expiration date 3/31/2027). A nurse went to remove a patient's dose from the automated dispensing cabinet (ADC) and, upon removing the overwrap, observed a black/brown substance resembling mold inside the sealed, unopened inner bag (**Figure 1**). The nurse never spiked or administered the product. It was immediately sequestered and reported to the pharmacy. The pharmacy removed the entire supply of 2,000 mg/100 mL calcium gluconate bags by Amneal from patient care areas.

Figure 1. A black/brown substance was found inside a sealed, unopened bag of calcium gluconate 2,000 mg/100 mL manufactured by Amneal.

We have reported this issue to FDA and Amneal. At this point, we do not know if this is the same issue as the WG Critical Care bags. These incidents underscore how critical it is for end users to stay vigilant in reviewing product integrity and to escalate potential safety issues. If your organization purchases calcium gluconate 2,000 mg/100 mL from Amneal or WG Critical Care, review your inventory and ensure end users are aware of this concern. If potentially impacted product is found, sequester it and report it to the manufacturer, FDA, and [ISMP](#). Remind staff to visually inspect all medication injectable solutions for particulate matter, discoloration, and potential contaminants prior to use.
